WANT TO NEGATIVELY IMPACT PROFITS? Simple. Ignore what you can't see.

True story. It happened to Ryan Cain, the General Manager at the Applebee's restaurant in Greenwood, Indiana in mid-November 2020. Discover how VASEY identified and solved the problem.

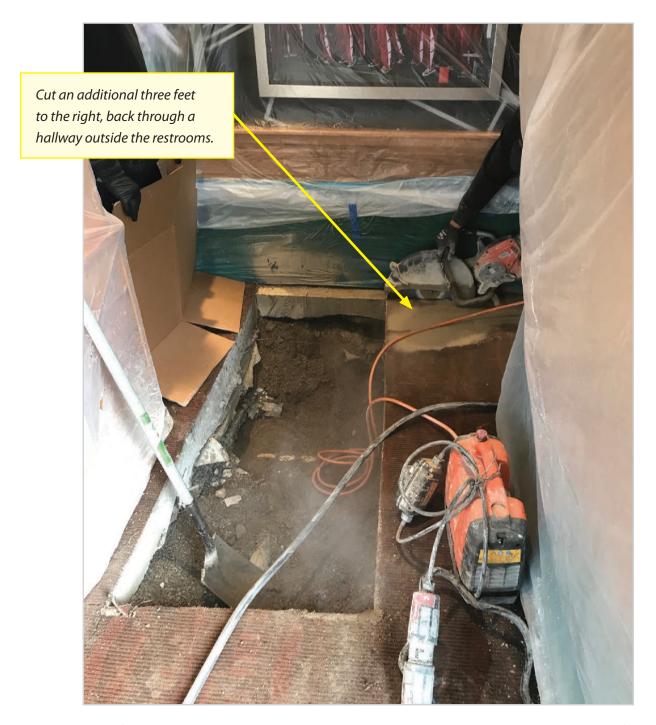
The first location dig site. Prior to being an Applebee's, the building was a bank. Instead of removing the old foundation, the builder poured a new foundation over the old. In total, it consisted of a 4-inch slab, followed by 10 inches of pea gravel, on top of another 4-inch concrete slab.

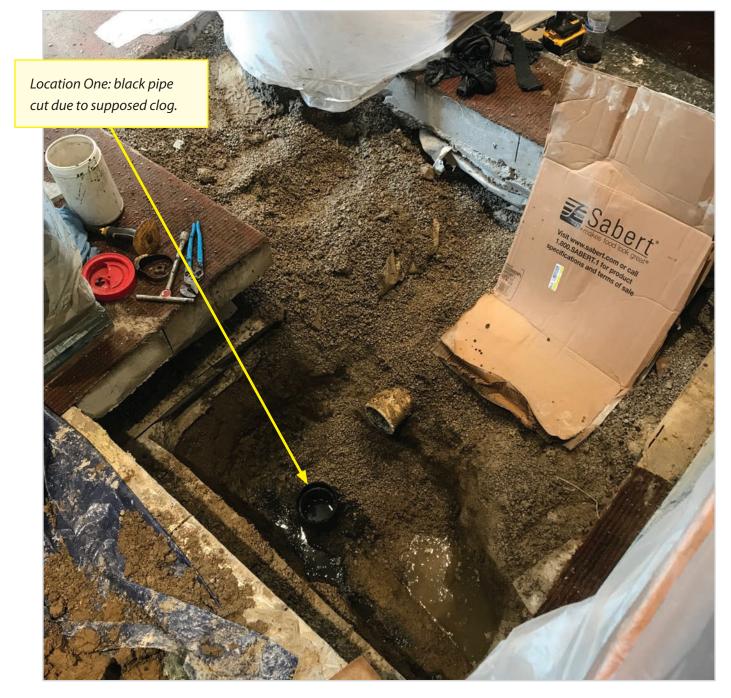
Tie in location for the bathrooms (to the left). VASEY inserted camera and drain-jetter to determine the true source of the problem.

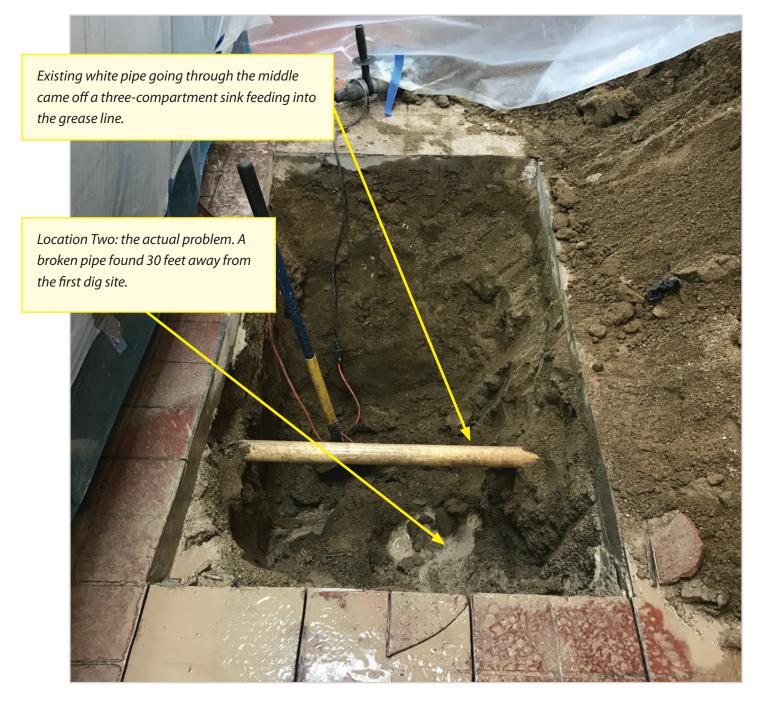
Dig Location Two: On the cook's line, about 30 feet away from Location One. On the right, sits the commercial stoves (where the sand and pea gravel are built up). On the left, the reach-ins, where all food is prepped. Due to the food prep line's location, the existing pipe was capped and a new line added, tying back to the restrooms. VASEY thoroughly inspected the entire facility to identify the grease and sanitary lines and what pipes fed into each system.

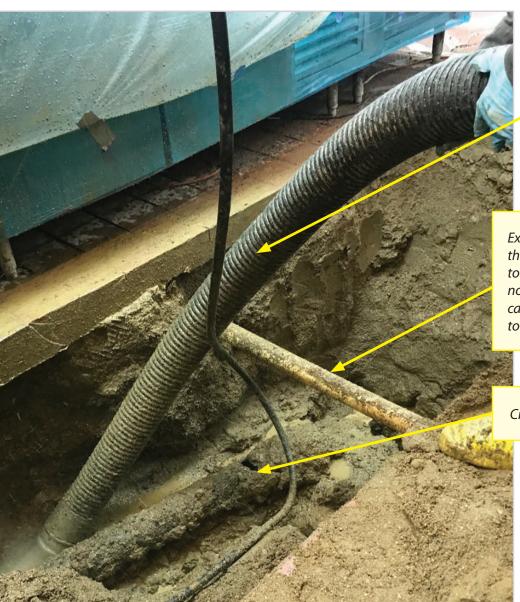
Existing white PVC pipe from a three-compartment sink feeding to the grease line – surprisingly not made of cast iron. Typically, cast iron is used since it can tolerate higher temperatures.

Cracked, broken cast iron pipe.

Dig Location Two: fully exposed, broken cast iron pipe. Once the damaged pipe was exposed, it disintegrated. Upon closer inspection, the entire pipe cracked along its bottom side (normally cast iron pipes fail "bottom up" because that's where the grease settles. The average life span of a cast iron pipe ranges from 20 to 30 years).

Toward the upper right, a hydro-vacuum which used high pressure water to break up hardened clay and dirt. The dry soil is turned into a wet slurry to facilitate removal by suction.

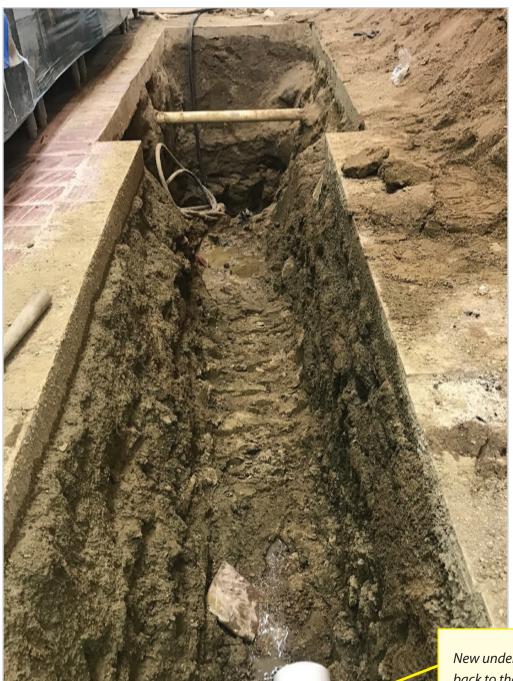
The power of Hydro-vacuuming: an 8-inch layer of sand and concrete-like dirt. The entire trench (4 feet wide x 10 feet long x 5 feet deep) was hydro-vacuumed quickly. Manually, with pickaxes and multiple men, it would have taken endless man-hours.

New underground PVC pipe leading back to the men's restroom.

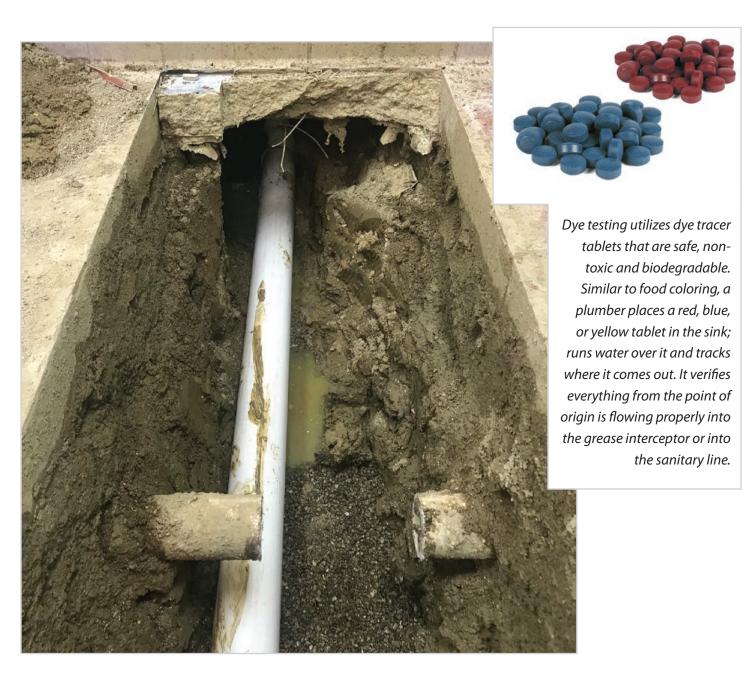
PVC pipe shown is going underneath the wall into the men's restroom. VASEY had to cut the floor and find a good place to tie in to allow the waste to drain from the bathroom to the white PVC pipe and out of the building.

VASEY cut the pipe in the fore front to verify the remaining floor drains throughout the facility and to make sure nothing was feeding back into the grease line. VASEY dye tested every drain and pipe in the facility, tracking its flow to make sure everything else was 100% correct.

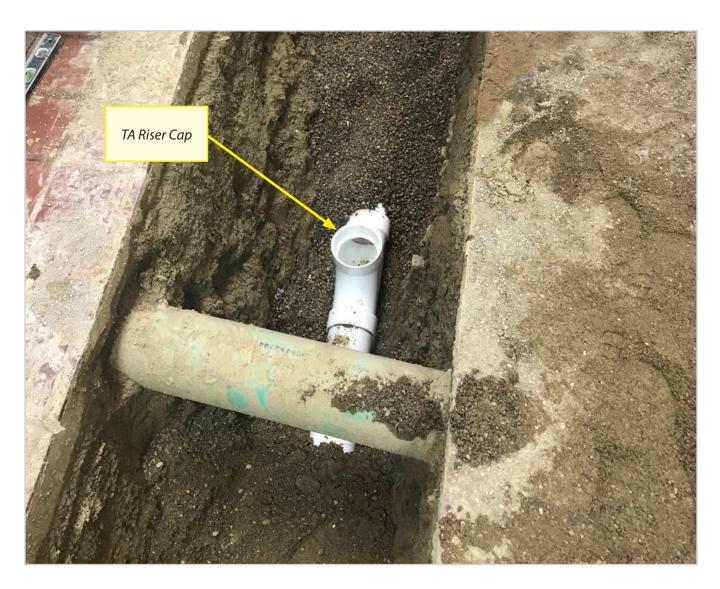
This is a clean out TA Riser cap which will come to the top of the floor with an access cap. In the future, if there's a problem within this line, it can be accessed easily, inspected and/or jetted.
