How preventive maintenance could have saved an area manufacturer from a paint booth fire, gruelling repairs and six weeks of downtime.

CASE STUDY

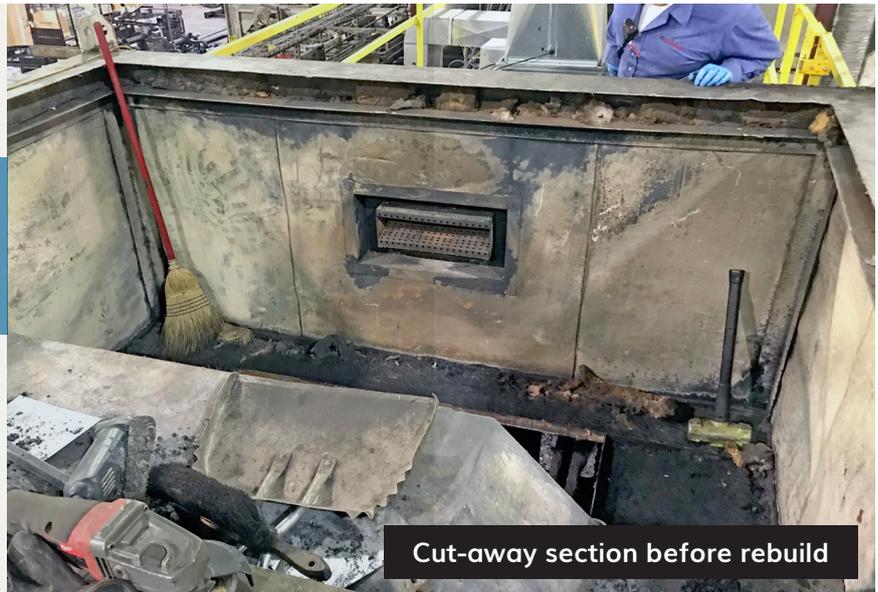
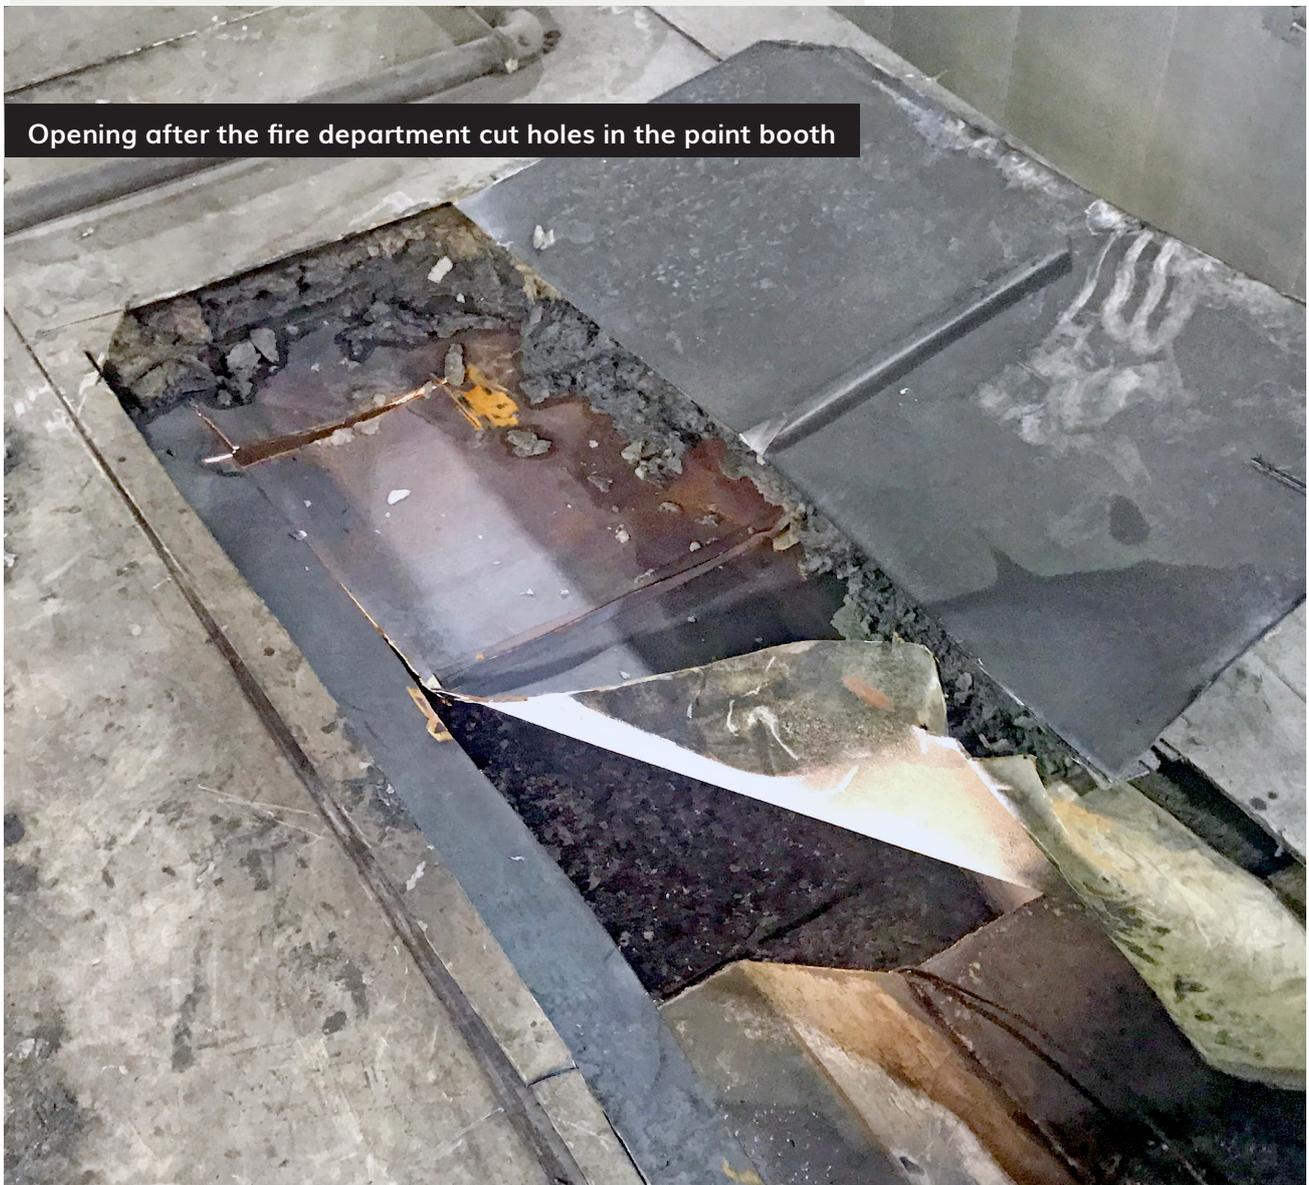
The Tear Out

The ductwork is located on each side of the burner (middle top).

The burner doesn't actually burn the paint particles. It provides heat to speed up the curing process.

The system created a circular motion to the air flow.

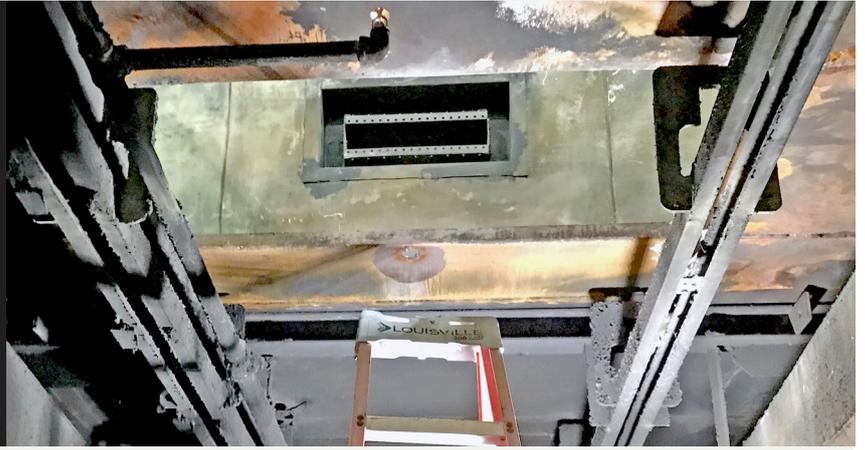
This is the cone-shaped opening of the blower housing.

Return air passed through this location where all the paint particles were pulled through the system.

The outer edge shows previous build up and our client's attempt to try and scrape off paint build up.

Everything was funneled back into the blower where particles were picked up and pushed back through and down into the paint booth ductwork.

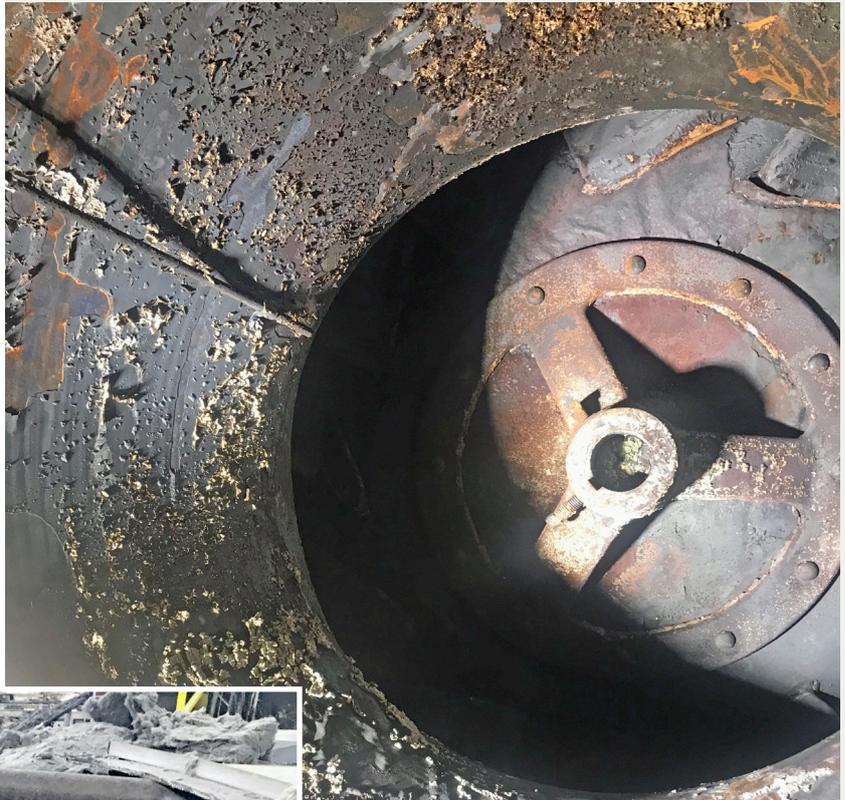
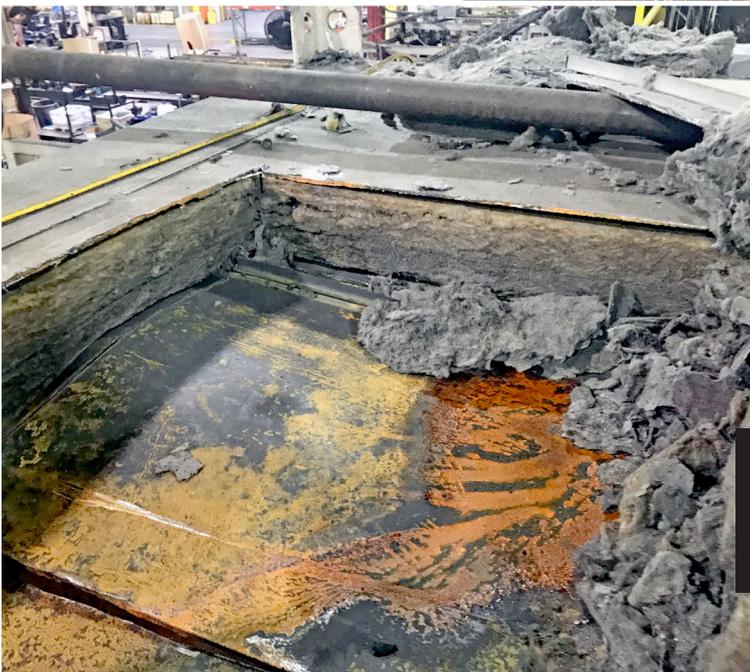
Affected area after all the ductwork and insulation are removed.

First, VASEY chiseled away at the paint build up with chipping hammers and removed burnt batt-type insulation - a long, tedious, and dirty job. Once the top of the paint booth was opened and cleaned, the existing steel panels were removed and replaced with 16-gauge welded steel panels, making it stronger since the old panels warped from the excess heat build-up.

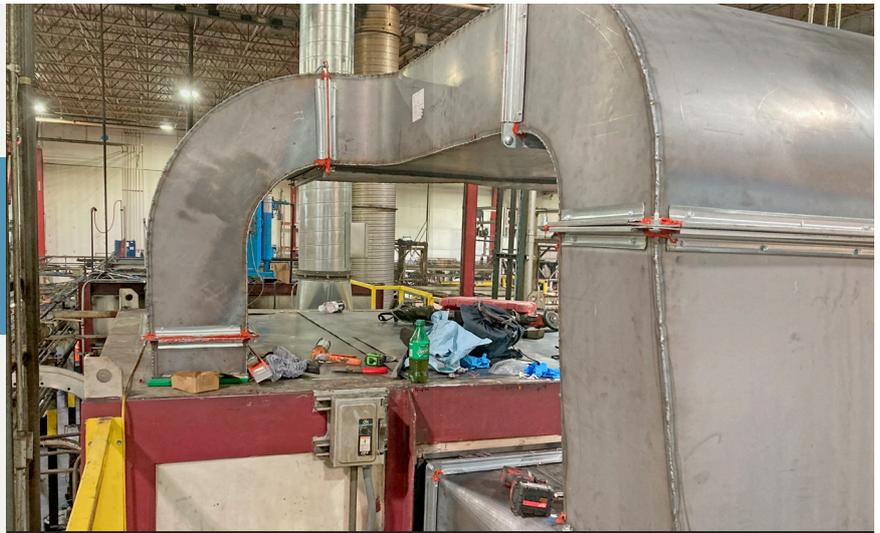
The ductwork coming off the top of the fan was directed straight down and tied into the ductwork on the inside of the paint booth.

We custom designed and installed a brand new ductwork system in addition to new openings and access areas for easier preventive maintenance.

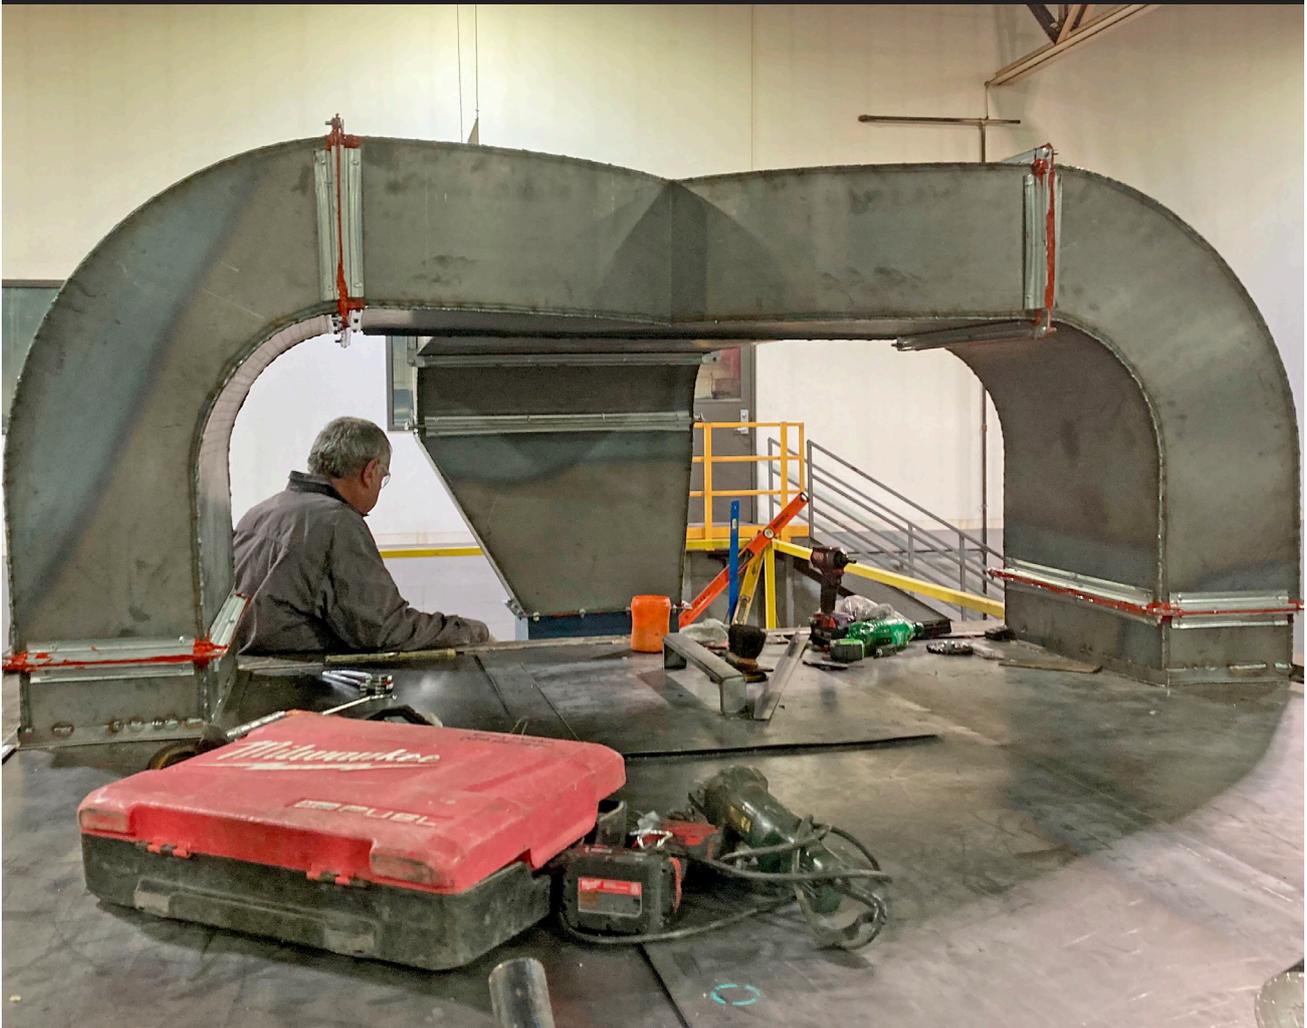
New top part of the system with the new panels in place. Notice the access door.
Client's maintenance team can now access the ductwork
to clean the system.

Once the new panels were in place, VASEY created an access door so maintenance could crawl inside for easy clean out. The new system now runs safely and efficiently at 140°F.

All materials were made on-site at the VASEY facility. No previous designs or plans
existed. The only information available – the size of the opening. The end result, a
new system 100% engineered from the ground up.

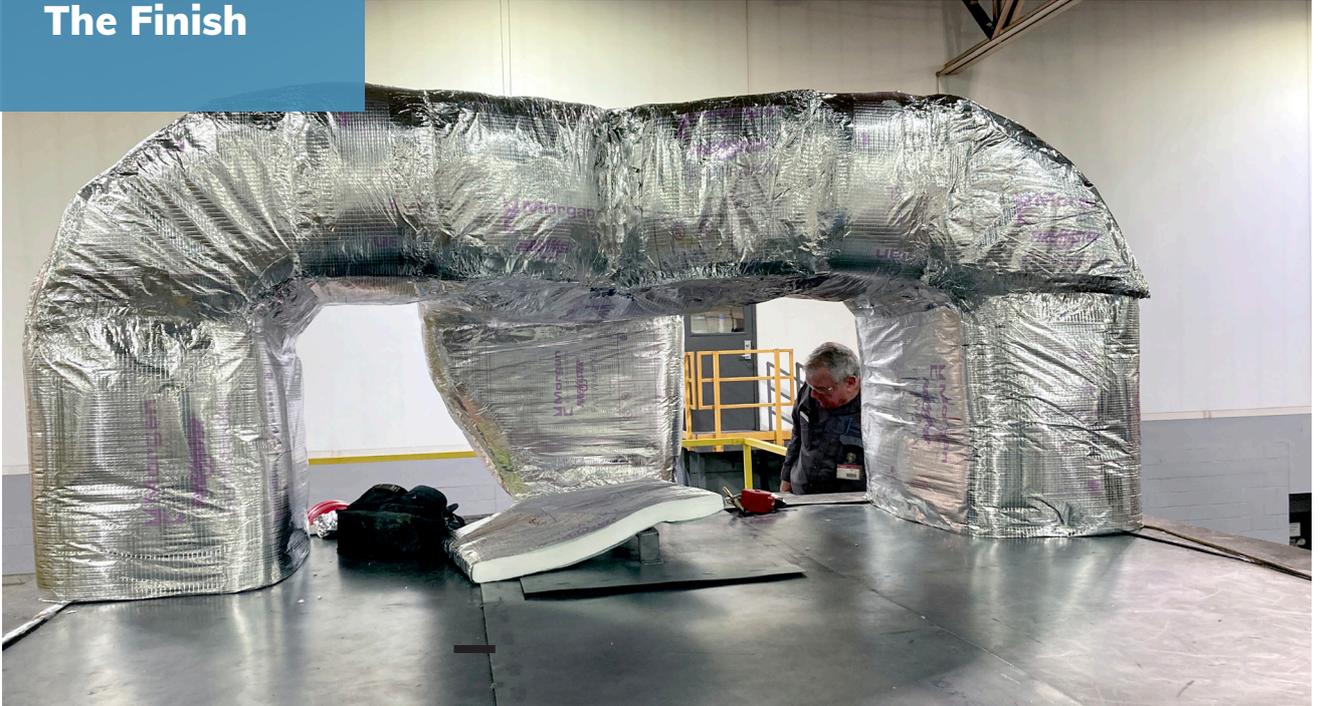
The Finish

By safely restoring the fire-damaged ductwork, the VASEY team saved the client more than \$250,000 (not including the associated lead time and installation costs necessary for an entirely new paint-booth system).
